**Docket No. 217 – Development and Management Plan Inspection**

**Date:** July 6, 2005

**Location:** 345 kV Underground Route

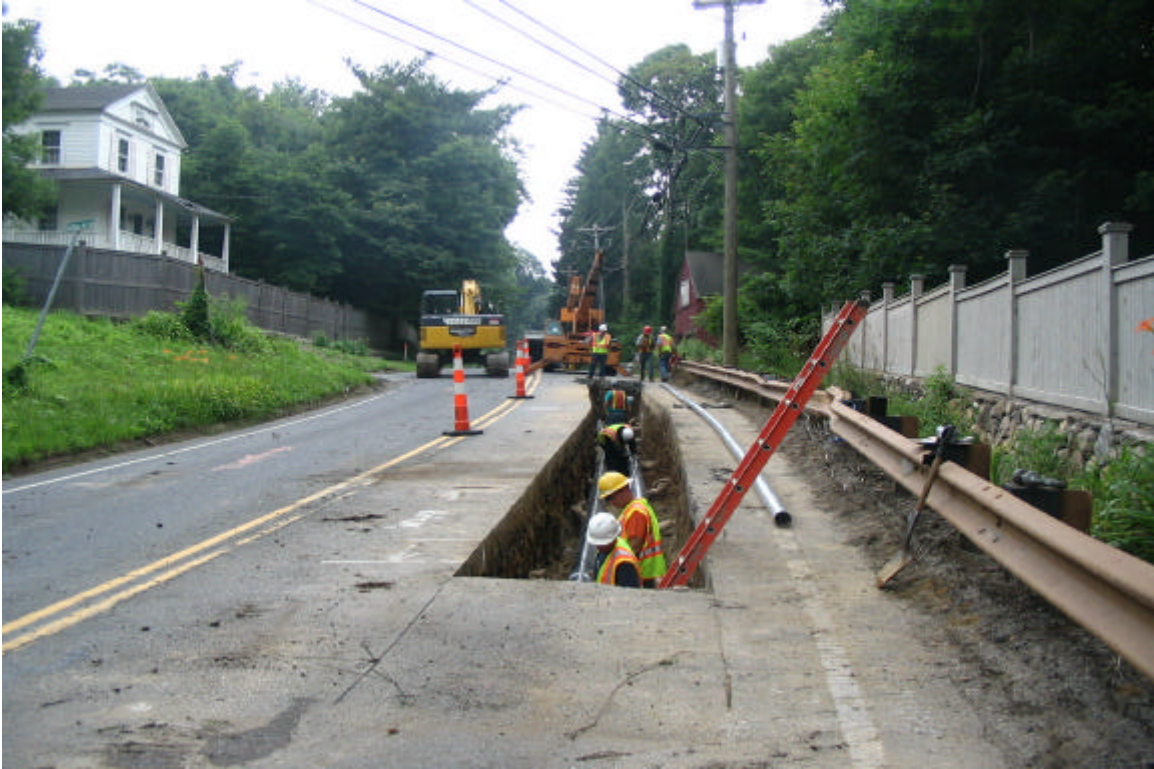
Route 107 near Umpawaug Road. Trenching and pipe installation had begun in this location on the day of the inspection. 7/6/05

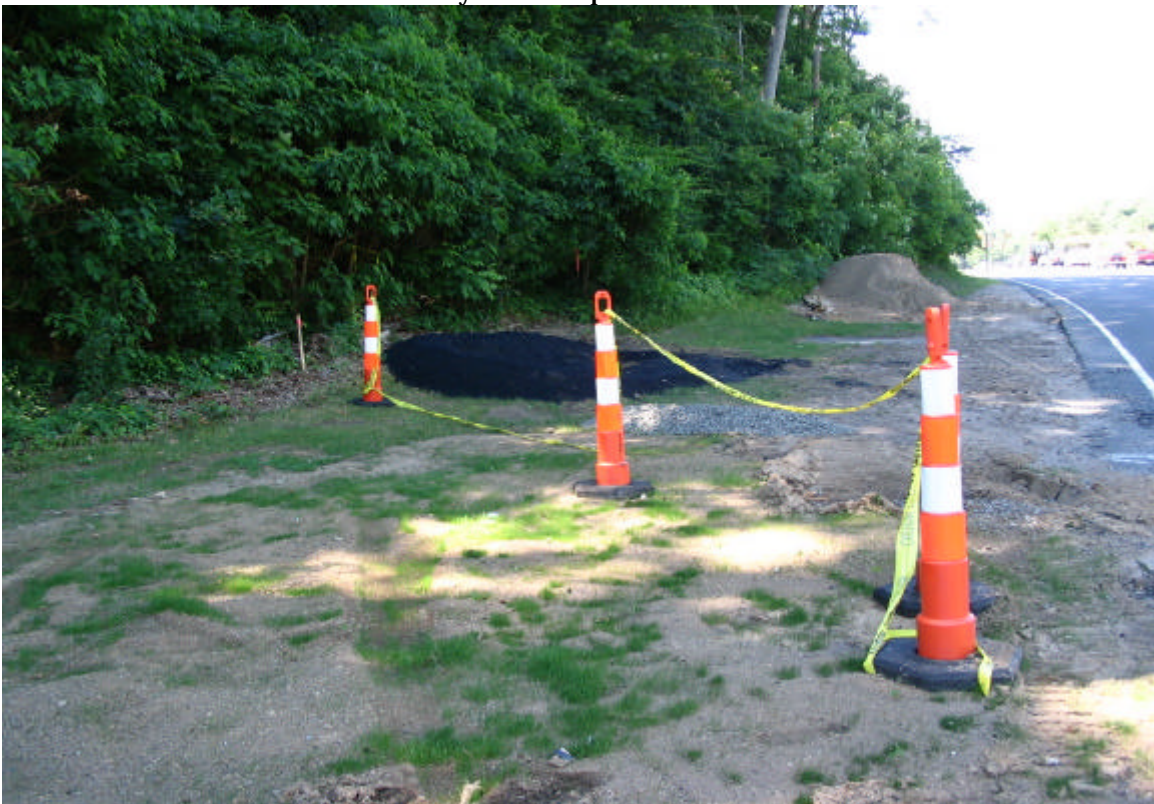
An asphalt and soil pile located near the intersection of Rt. 107 and 7 should have haybales or silt fence at their base to prevent sedimentation. 7/6/05

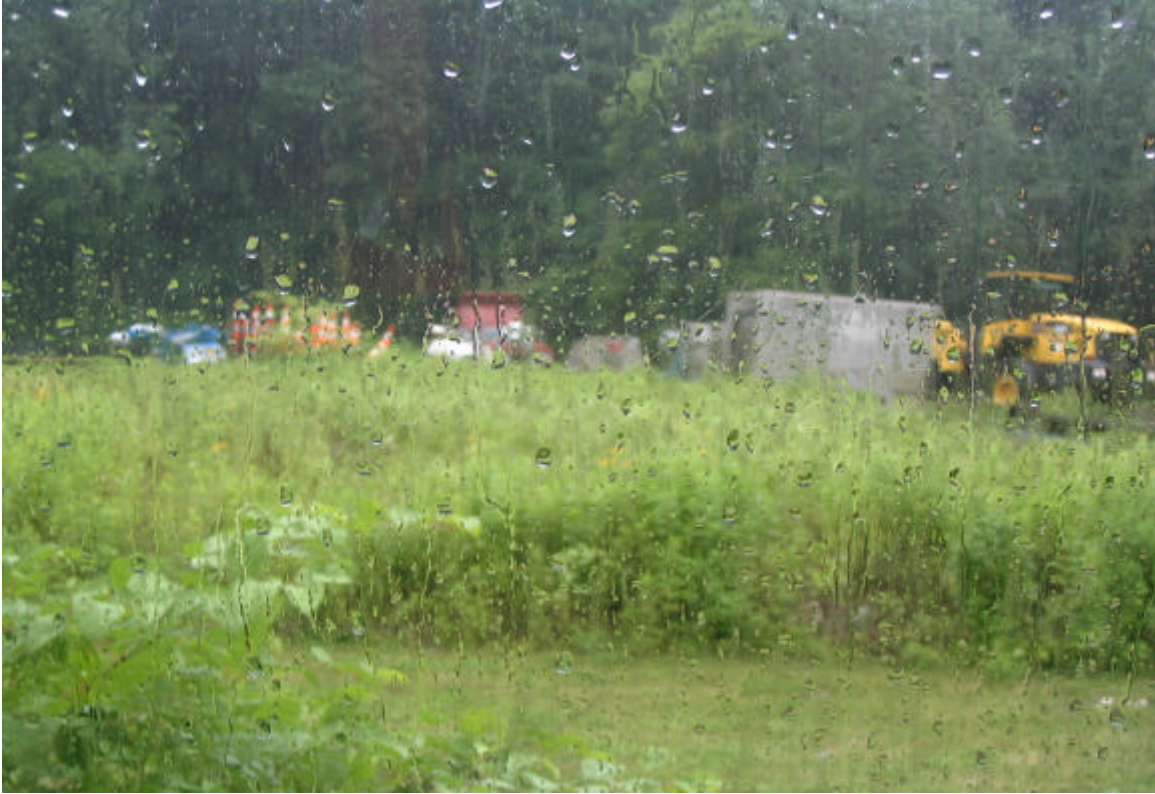
A rainy view of the storage area off Rt. 7 in Wilton. 7/6/05

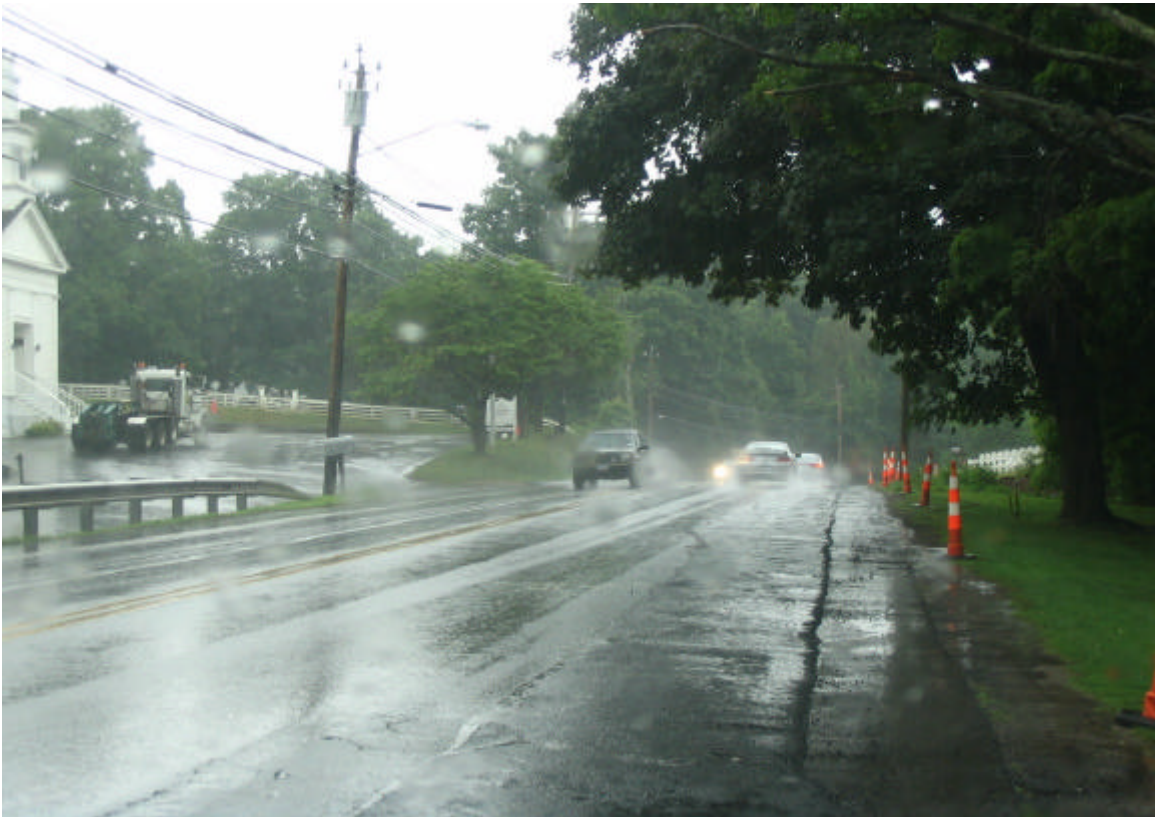
View of the recent area of trenching across from the United Methodist Church. 7/6/05
